November 19, 2020

Subject: **Report of Fire Testing**
Project Name: STI Fire Stop Mortar
TEC Project No.: 10-0860
TEC Laboratory No.: 20-1454-2

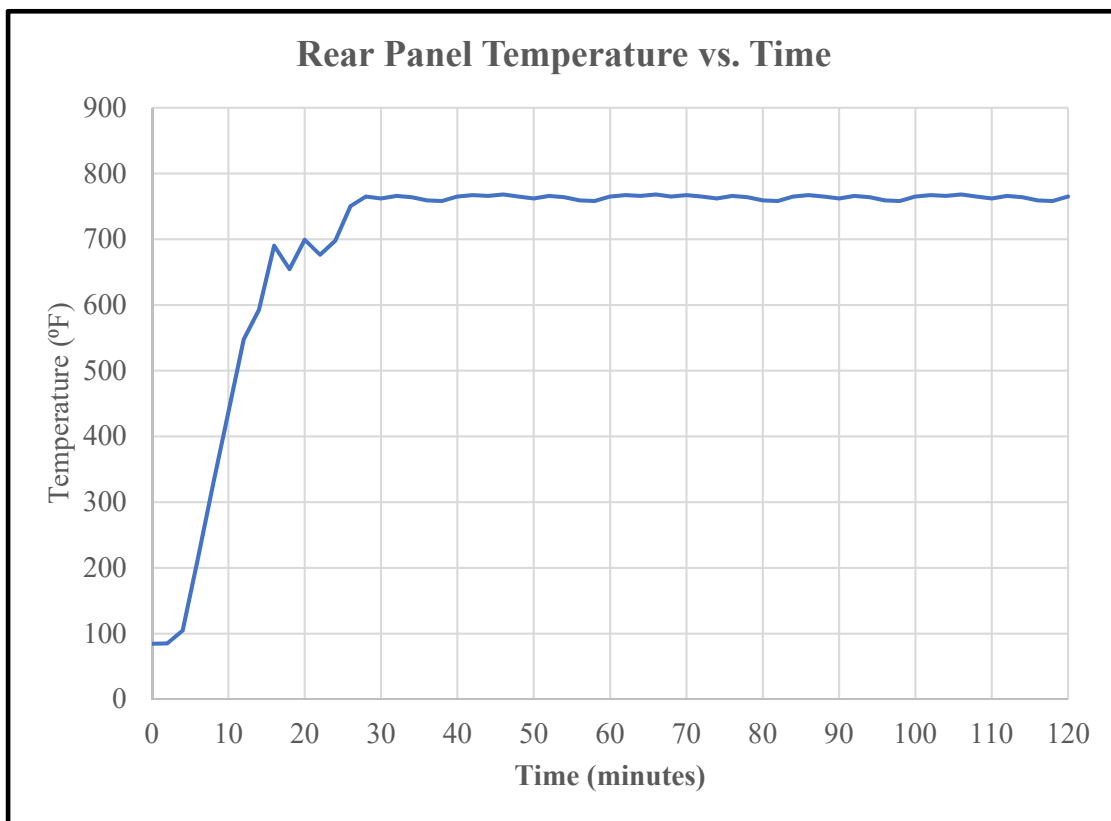
Figure 1 – ¾” Round Panel

| Sample ID | Round Panel |
|---|---|
| Nominal Temperature at Front of Panel For Test Duration | 2243°F |
| Average Temperature at Rear of Panel for Test Duration | 763°F |

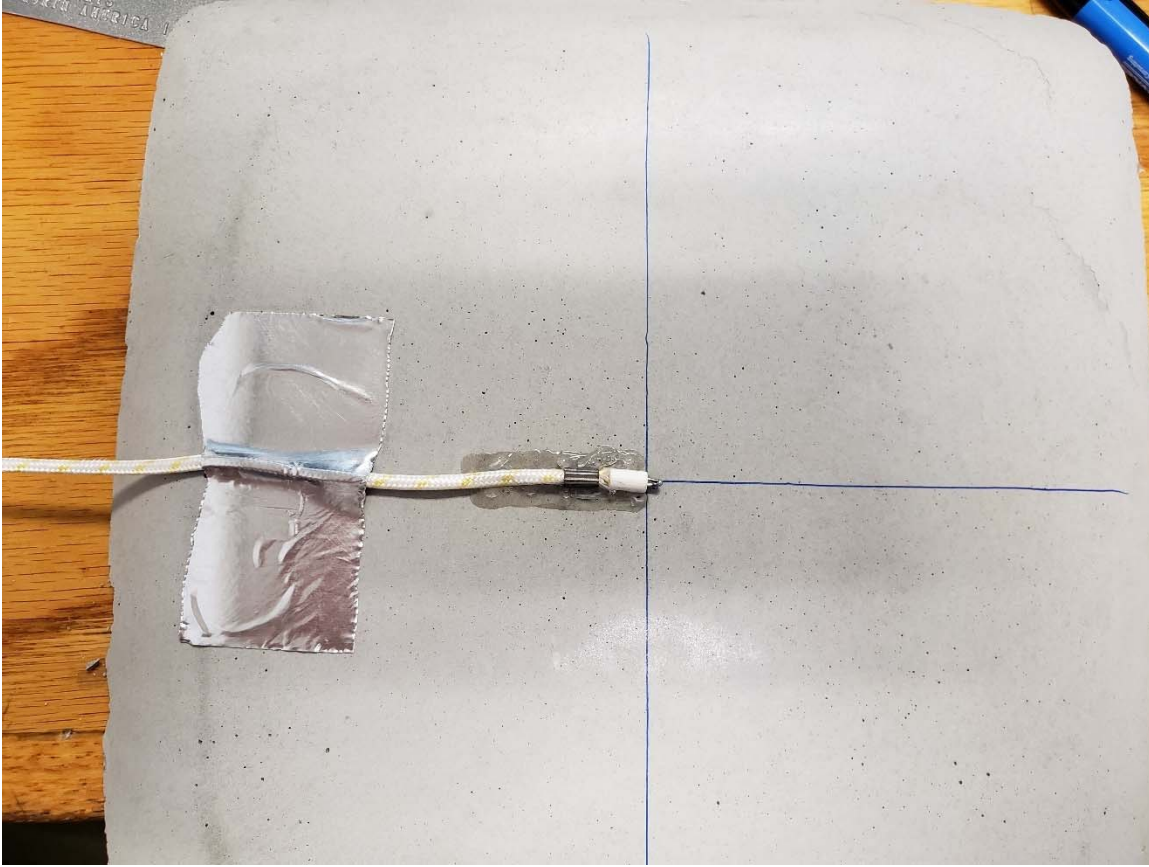
Photo 1 – Thermocouple Bonded to Rear of Panel

The purpose of the testing was to subject each panel to a flame heat source with an approximate intensity of 2200-2300°F for a duration of 2 hours and record the temperatures on the rear of the panels using a high temperature Type K thermocouple in conjunction with a Graphtec data acquisition system. Plots for each panel are attached to this report. The heat source utilized was a portable torch (Benzomatic TS4000) fueled by a MAP-Pro gas cylinder (manufactured by Benzomatic). The portable torch was horizontally restrained and manually positioned so that the flame of the torch was approximately located 1” away from the panel center. The front panel temperature was monitored throughout each test using a BT-1500 Infrared Thermometer.

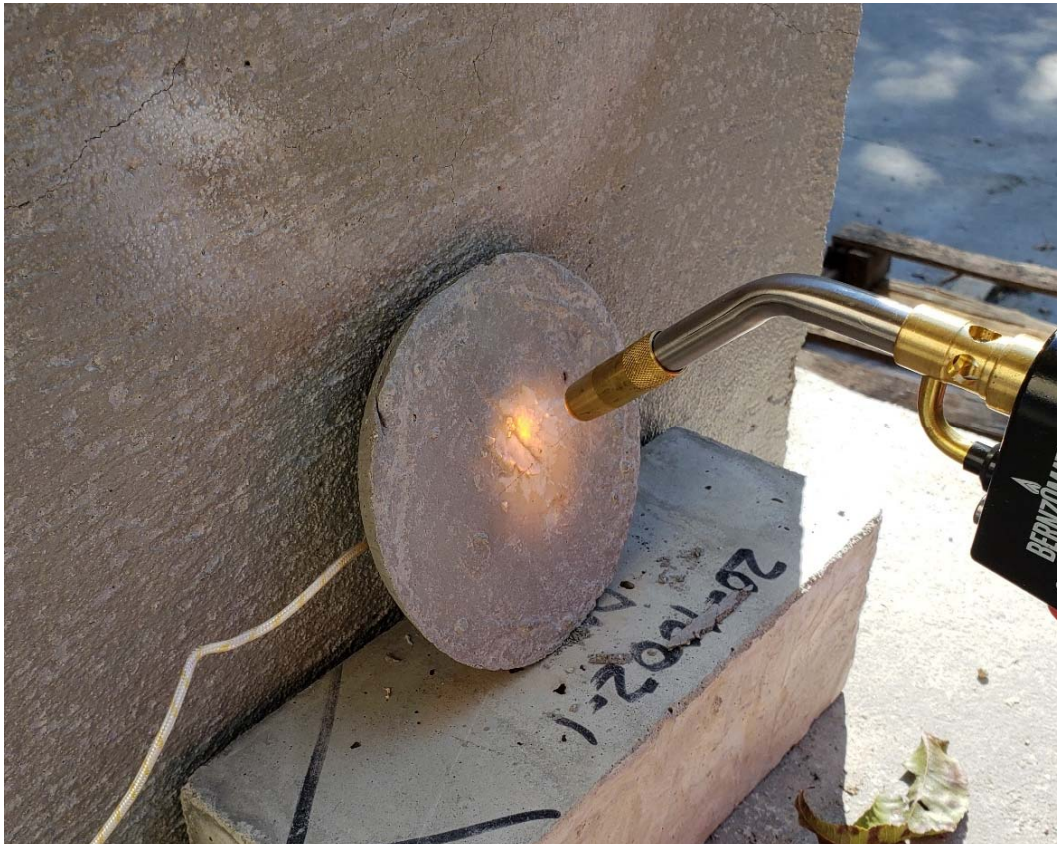
Photo 2 – Test Configuration for 3/4" Round Panel

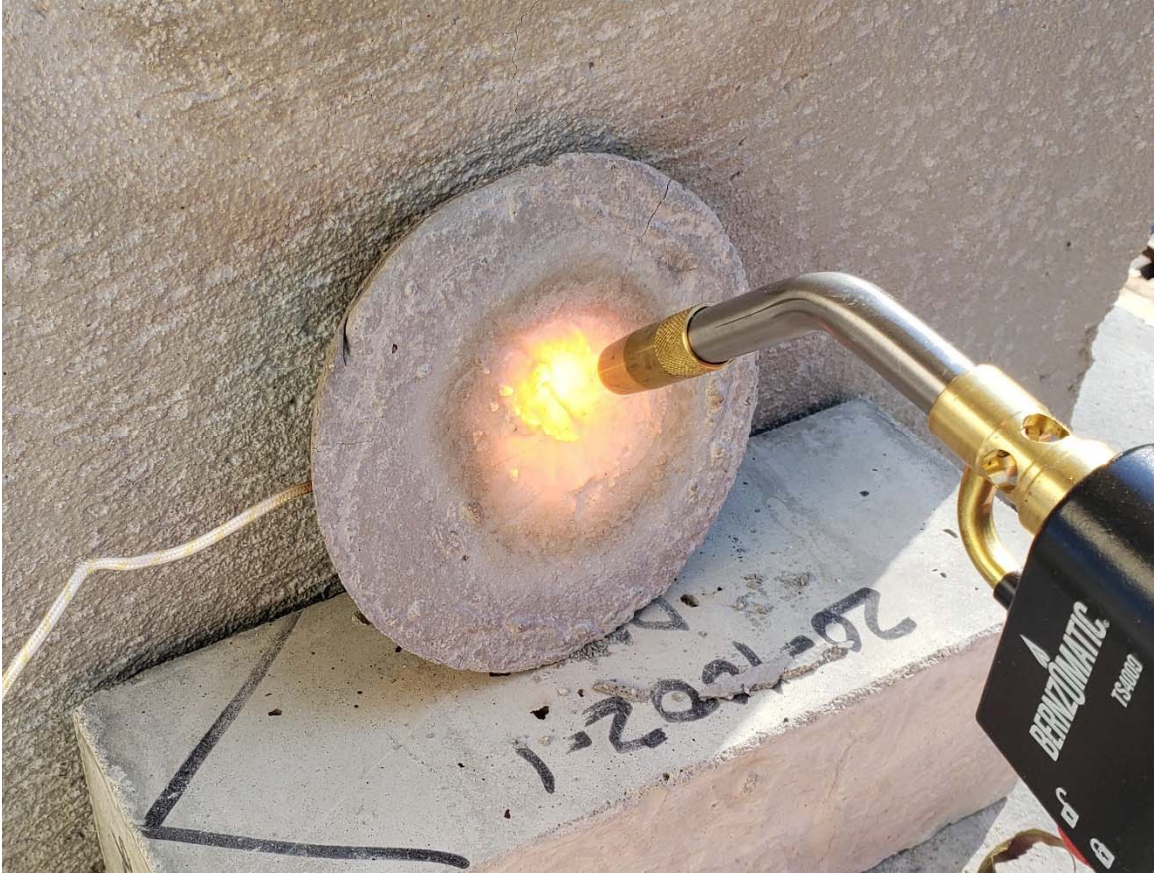
Photo 3 – ¾” Round Panel at 2 hrs

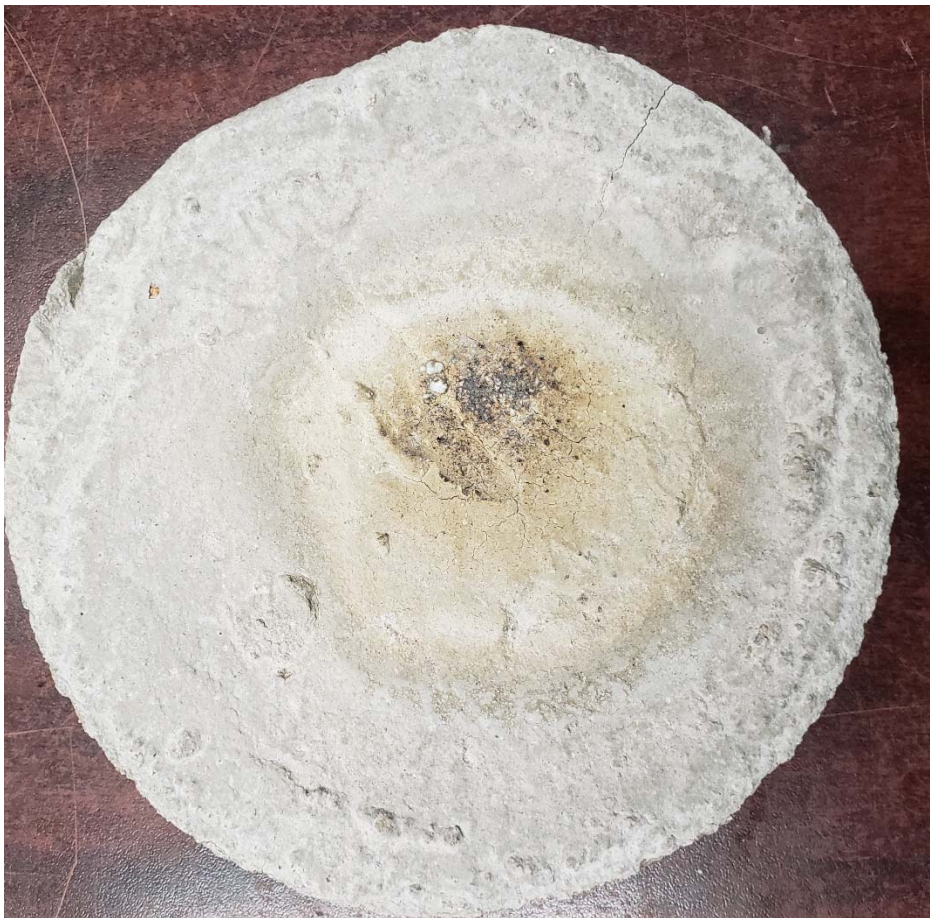
Photo 4 – Front of ¾” Round Panel once Cooled

The sample exhibited signs of cracking early on in the test at approximately 4-5 minutes. The ¾” round panel did exhibit a single small crack that extended from the top to the center of the panel on the front surface. The crack did not extend through the entire depth of the panel. Details pertaining to the panels are reported in Table 1. Select photos of testing are attached to this report.
